Subject: Response to Request for Information for Site 4, Pursuant to Section 104(e) of CERCLA; Johns Manville, 1871 North Pershing Road, Waukegan, Illinois

JOHNS MANVILLE, WAUKEGAN, ILLINOIS
GENERAL PROPERTY MAP

JOHNS MANVILLE, WAUKEGAN, ILLINOIS
**Site 4 and
Soil Boring Locations**

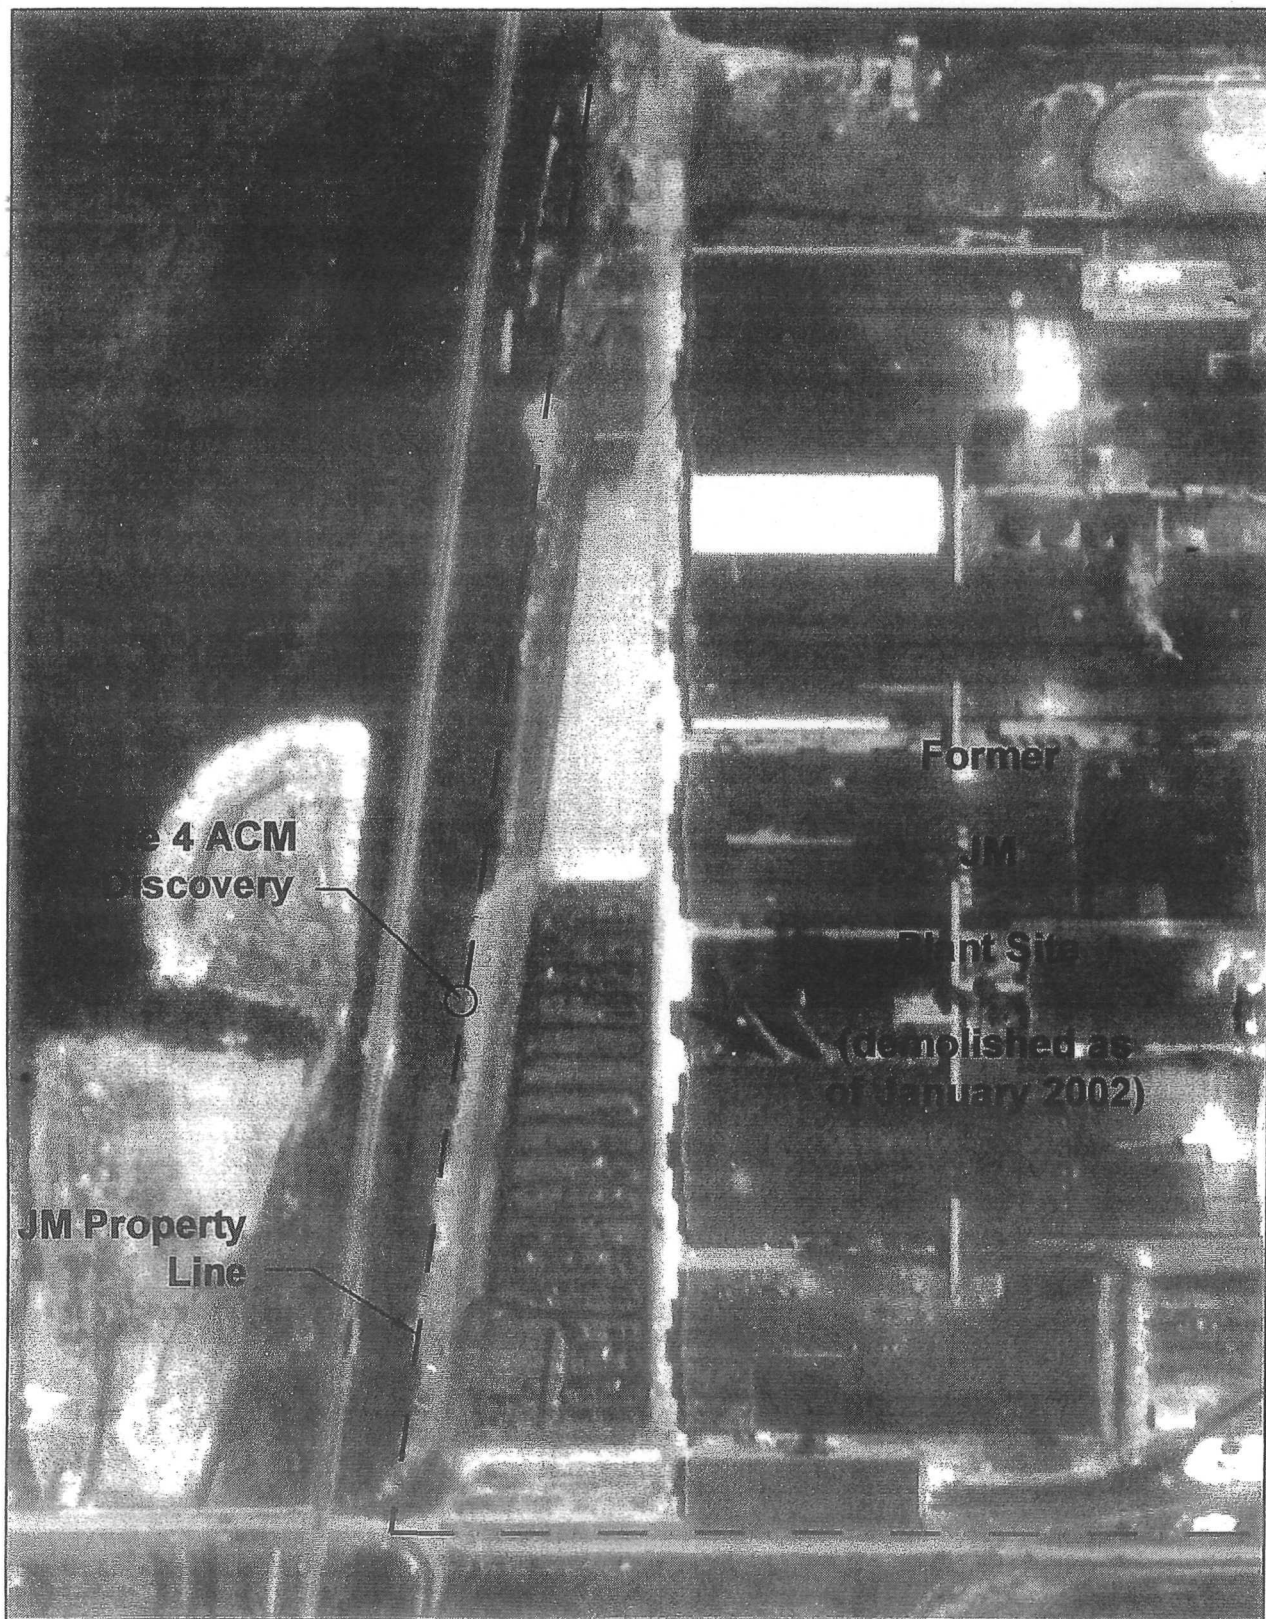
Exhibit 2

July 1946
Aerial Photograph
Site 4 ACM Discovery

Unknown. JM is not aware of any records that describe when placement of the fill materials may have occurred. However, review of historical aerial photographs shows that, with one exception (as described below), the western edge of the parking lot was substantially unchanged after 1946. Exhibit 10 is an overlay map showing the current Property features overlaying the 1946 aerial photograph. The map shows that, in 1946, the western limit of the parking/driveway area appears to extend to its present-day limit. This also roughly corresponds with the western JM Property line. As the elevation of the Site 4 area is no higher today than the surrounding drive and parking areas, it is unlikely that any fill material has been placed since 1946.

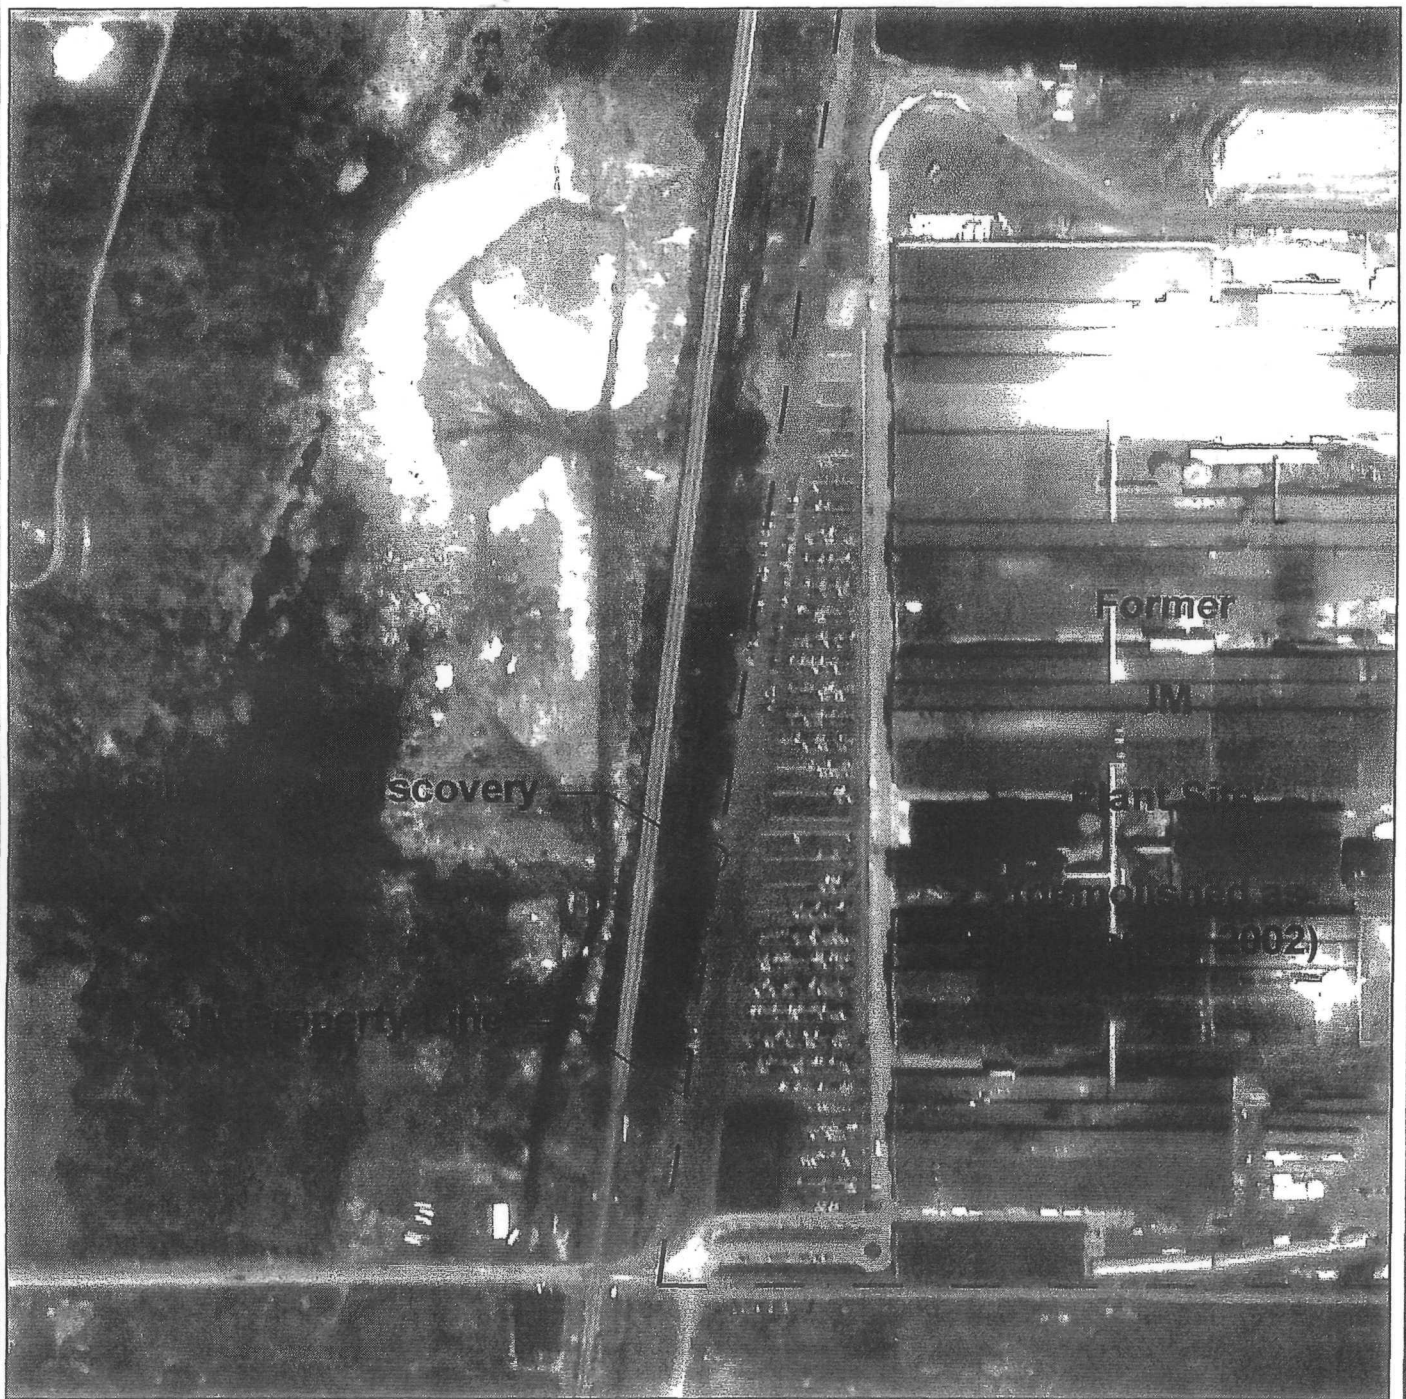
Exhibit 3

May 1953
Aerial Photograph
Site 4 ACM Discovery

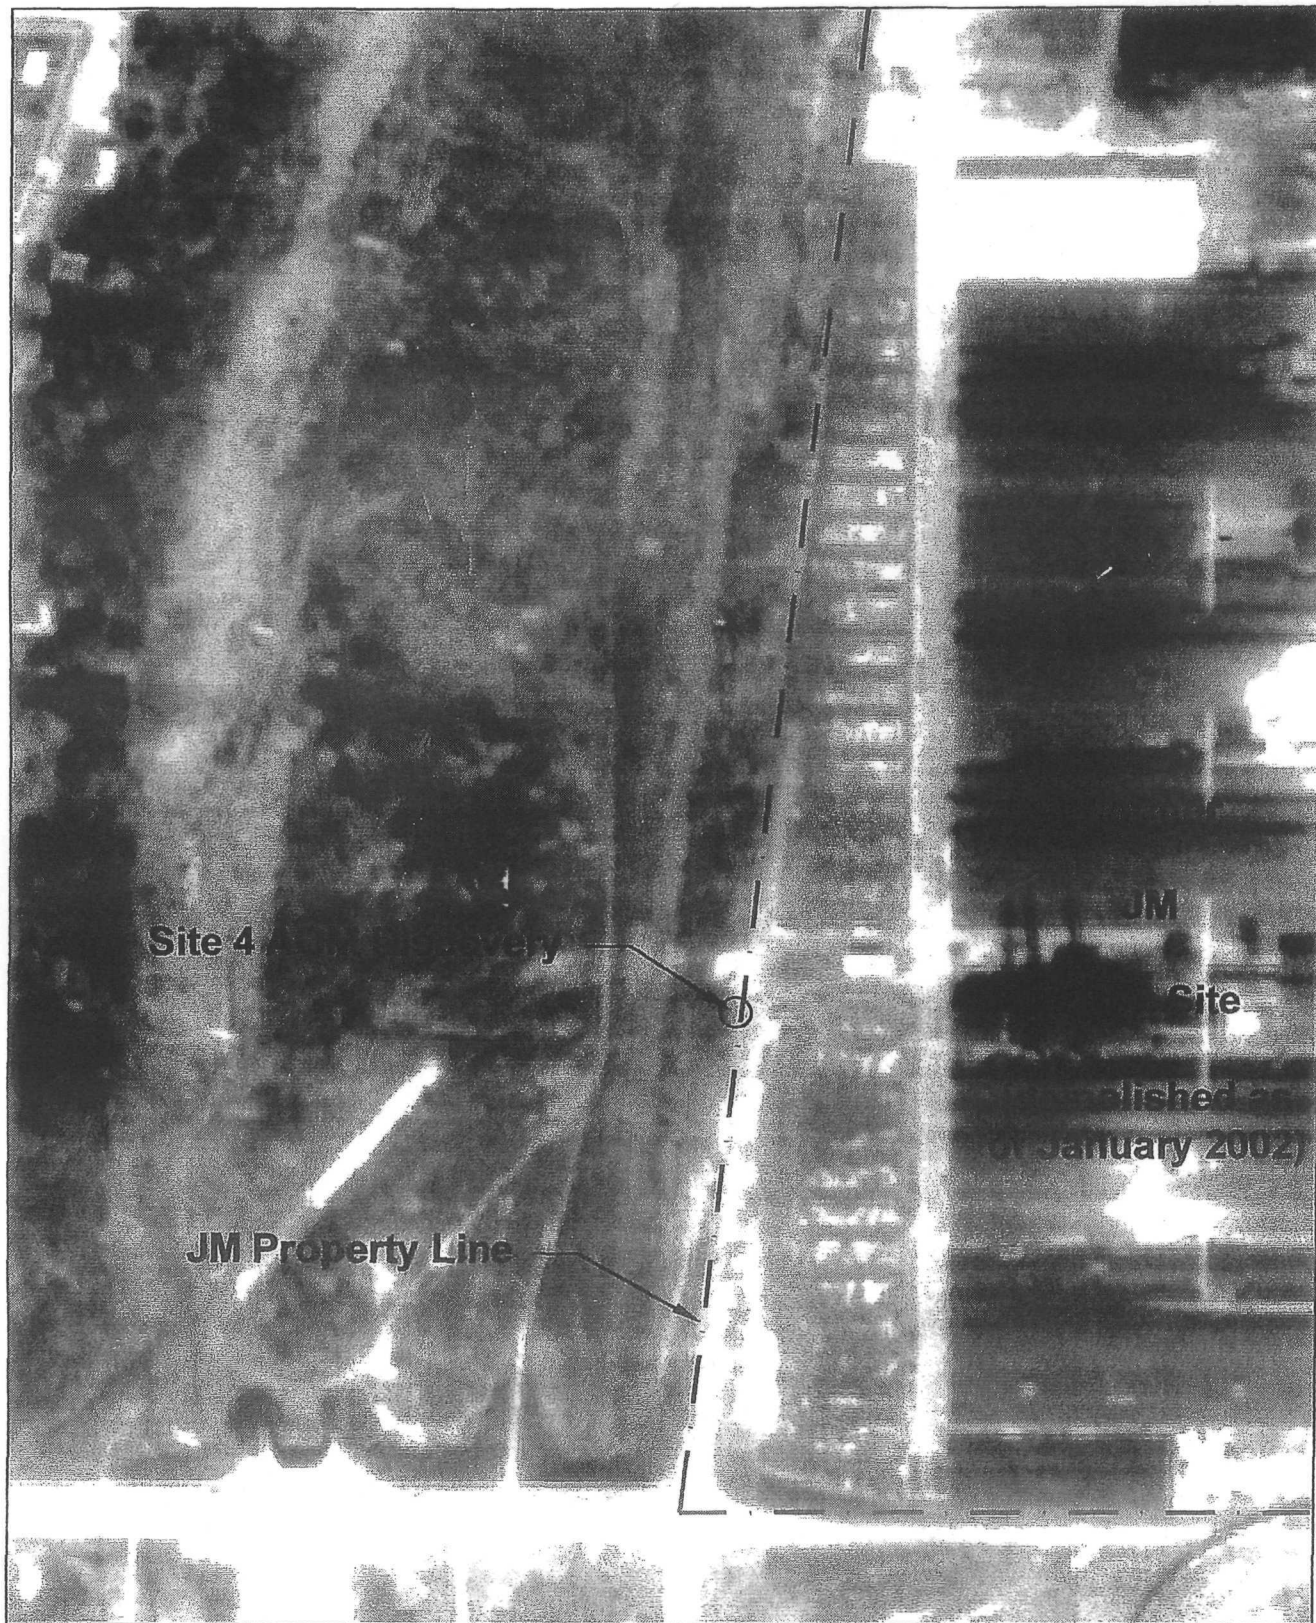
Exhibit 6

October 1978
Aerial Photograph
Site 4 ACM Discovery

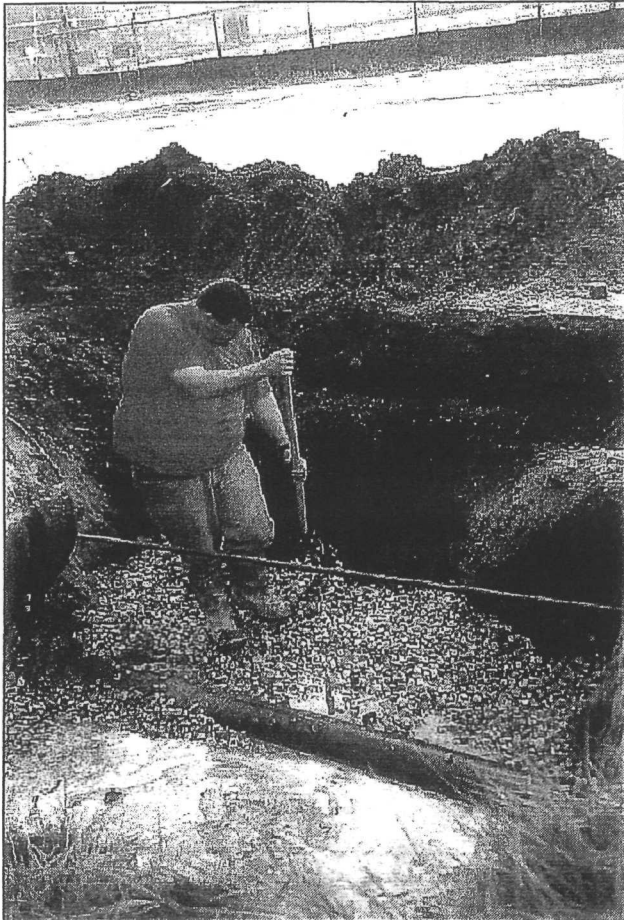
Exhibit 9a

The Site was discovered on October 26, 2000 while excavating soil to permanently close the natural gas supply line to the Property, which was in connection with demolition of the buildings on the Property. North Shore Gas was present to conduct the excavation and close the line. Pieces of ACM in the form of roofing materials, Transite sheeting, and brake shoe materials were noted in the excavated soil. David M. Peterson of David M. Peterson, PE, PC was present as a representative of JM and observed and photographed the excavated materials. Copies of 2 photographs are presented on Exhibit 9. All excavated materials were returned to the excavation. All ACM exposed at the surface as a result of the excavation was picked up by a licensed asbestos contractor (Omega Demolition Corporation) and placed in one of the roll-off boxes present at the Property in connection with the ongoing building demolition. All ACM from the surface pick-up, as well as the building demolition, was disposed off-site at the Onyx Landfill located in Zion, Illinois.

Johns Manville - Waukegan, Illinois
 October 26, 2000
 Natural Gas Line Excavation
 Site 4 ACM Discovery
